Bass Lake Outlet Berm Investigation

Township of Rideau Lakes
1439 County Road 8
Delta, Ontario
K0E 1G0

Jp2g Consultants Inc.

August 29, 2019

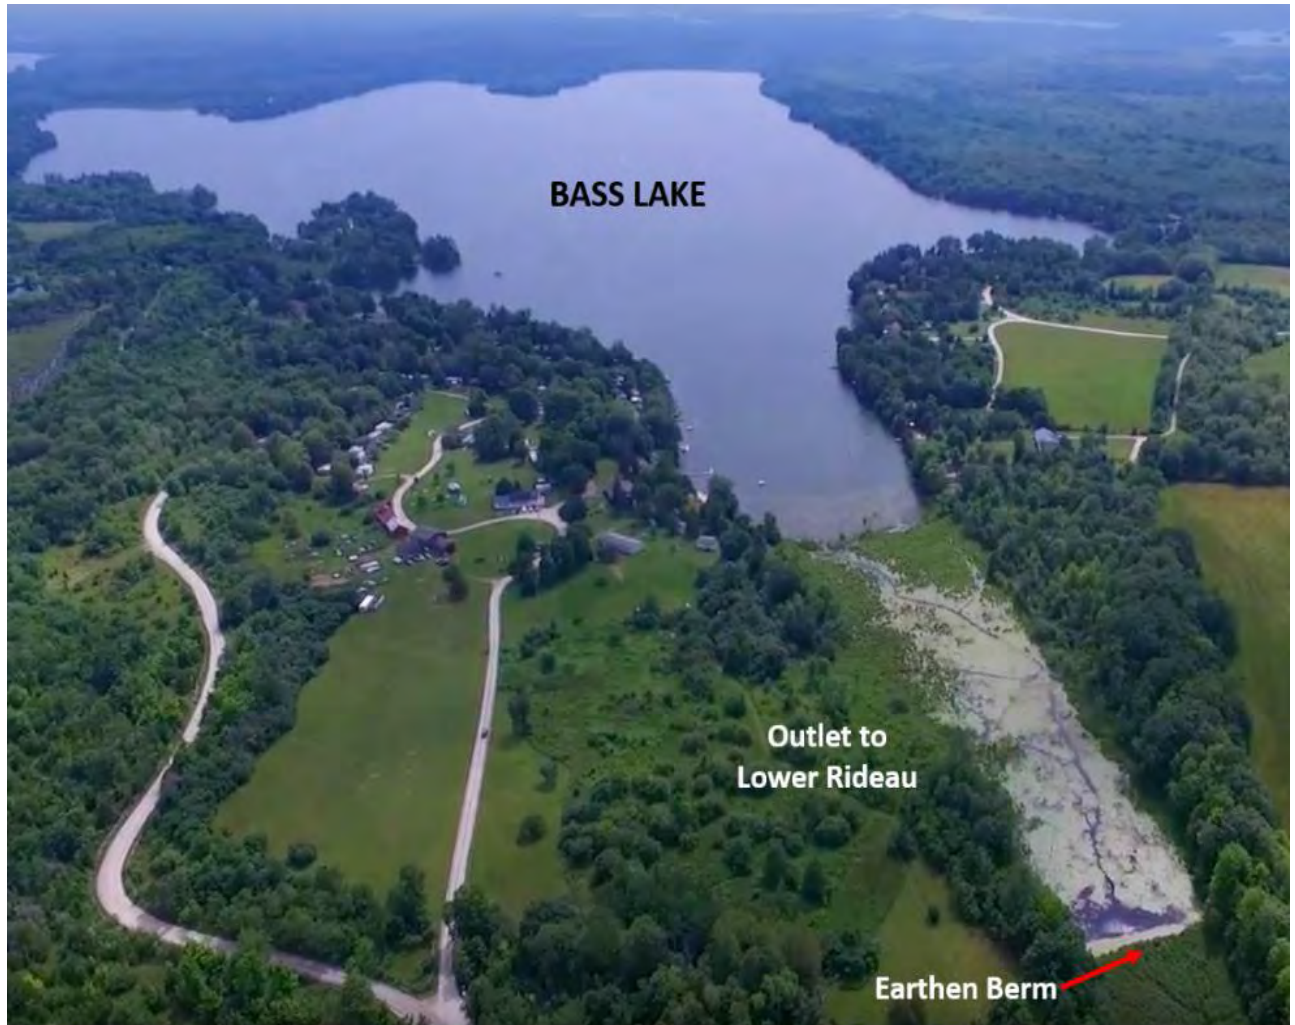
Figure 1-2. Outlet channel of Bass Lake (Twp of Rideau Lakes, 2018)

Figure 1-1 shows a satellite view of the area while **Table 1-1** shows the specific land use breakdown. **Figure 1-2** shows Bass Lake from an aerial view above the existing berm, looking south.

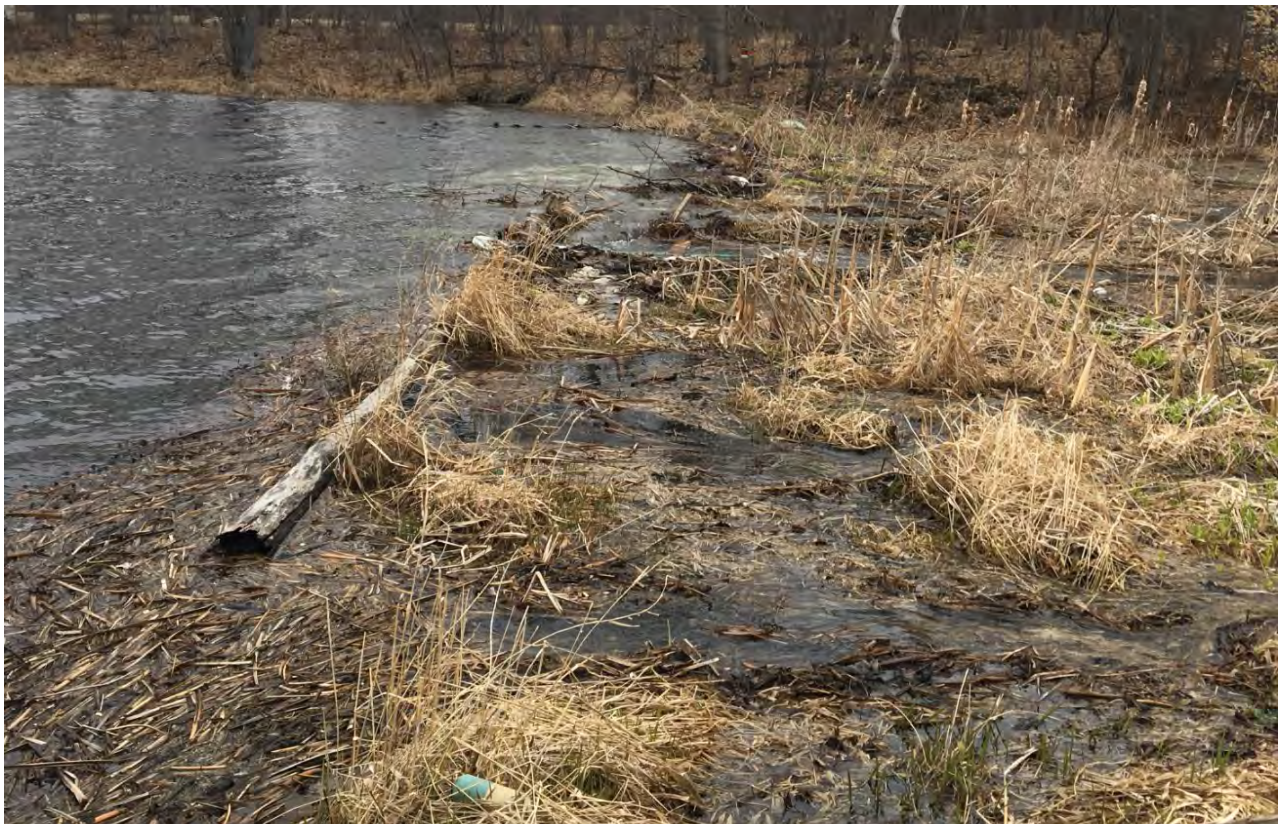
Figure 2-1. Bass Lake berm, April 18, 2019

structure and many spill points or channels could be seen having formed along the berm and braiding together immediately downstream of the structure. Flow overtopping the berm had noticeable velocity, including wind-driven wave action; flow downstream of the berm had little velocity, with the channelized overtopping flow quickly dispersing into a wetland environment. Despite the elevated water levels, the berm's "spillway" had accumulated significant debris with a stagnant flow and did not appear to serve its apparent intended purpose. This suggests that the original berm elevation was higher than what was observed during the site visit and has since deteriorated, rendering the spill way obsolete or with limited functionality. Survey results from July 2010 showing a top of berm elevation of 134.5 m, along with water level and channel bottom profile elevations.

It is recommended that the Township initiate detailed analysis and design of the preferred outlet control in a timely fashion to reduce the chance of a sudden failure of the existing berm. The berm should be regularly inspected in the meantime for signs of further deterioration. If the berm shows signs of imminent failure, it is recommended that the Township rehabilitate the existing berm as best as possible to maintain the current levels in order to preserve wetland functionality and protect the riparian rights of both up- and down-stream stakeholders. This could be done in conjunction with design and analysis of a permanent outlet control.

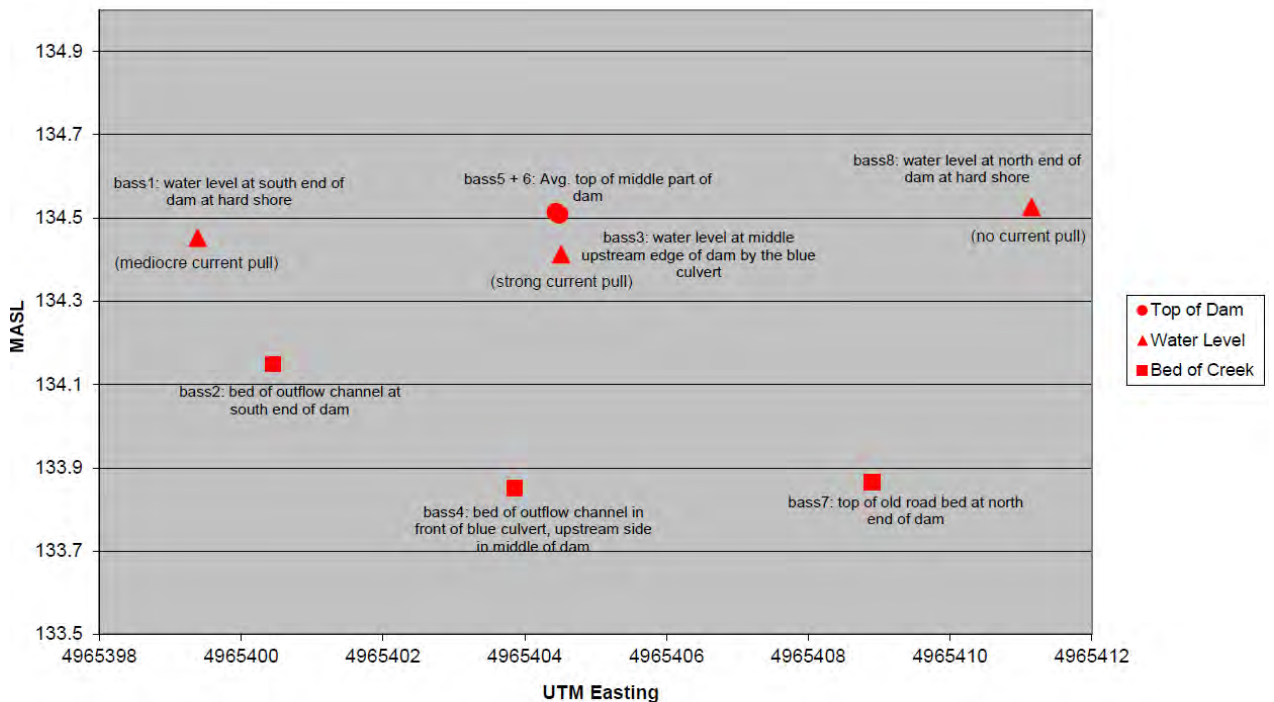
Figure 2-3. 2010 Survey data showing top of berm, water surface, and channel bottom profile elevations

**Bass Lake
 Bed of Creek and Water Level Elevations at outflow control (Causeway/beaver dam)
 Survey date: 2010.07.08**

Additional survey data was commissioned in August 2018 by BLPOA to establish more recent water level and berm elevation data. A total of 14 spot elevations were taken, representing the top of berm elevation and water surface elevation of the lake. The average for each location is shown in **Table 2-1**. Note that the average elevation for the top of berm is 0.3 m lower than the 2010 survey data, potentially indicating a corresponding deterioration in the berm's structure over the eight year period between surveys.

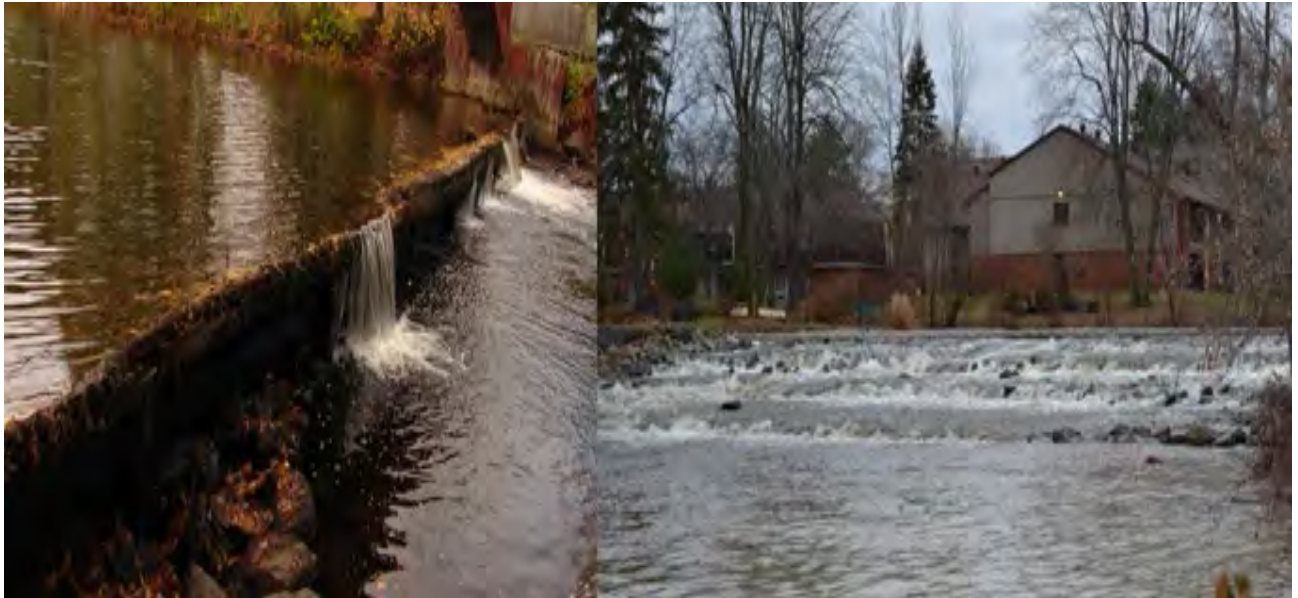
Figure 4-1. Before and after conversion of a traditional structural (wooden) weir to a rocky ramp

A naturalized outlet could be achieved by installing boulders, armour stone, and rip rap at set elevations, creating a hydraulic control system along with an environment amenable to ecological function, habitat, and fish passage. This hydraulic control would be similar to that of a typical structural berm, as illustrated in **Figure 4-1**. This option has potential for the greatest ecological and aesthetic benefits while carrying the least ongoing inspection and maintenance resources. However, the design and construction processes must be carefully considered and managed to ensure the hydraulic constraints are satisfied. It should also be noted that a properly constructed rocky ramp weir has the lowest risk of sudden or catastrophic failure due to the construction method of the rocky ramp: massive boulders are embedded in the bottom of the channel to a depth that they are sufficiently stable under all anticipated conditions. In contrast to a conventional structural weir of concrete or wood, the boulders will not show signs of wear and deterioration within the typical 20-50 year life span, yet if designed and built correctly can provide a similar hydraulic control. This option may be a way to avoid the issue of property access and ownership and responsibility of the weir – once constructed, there would not be a conventional structure to be owned, operated and maintained – the channel would be restored to a “natural” condition with water surface elevations fluctuating within the desired range.

Option 3 – Rocky Ramp Weir received the highest score. This option would set a lake elevation according to stakeholder input – providing a similar hydraulic function as a conventional weir – but would eliminate the need for a structure requiring ownership, operation, and maintenance. The channel would be restored to a natural condition conducive to wetland habitat and fish passage, while the overall lake environment would be maintained to the condition that residents, flora, and fauna have adapted to over the past 20 years. The lifecycle liability and costs of this option are significantly less than a structural hydraulic control but the construction will require detailed design and oversight and carries some risk due to the unconventional design.

As described in Section 5 above, **Option 3 – Rocky Ramp Weir** is the recommended course of action. This option is the least likely to incur liability to the Township, while satisfying stakeholder and environmental concerns and minimizing the life-cycle costs compared to a typical structural weir.

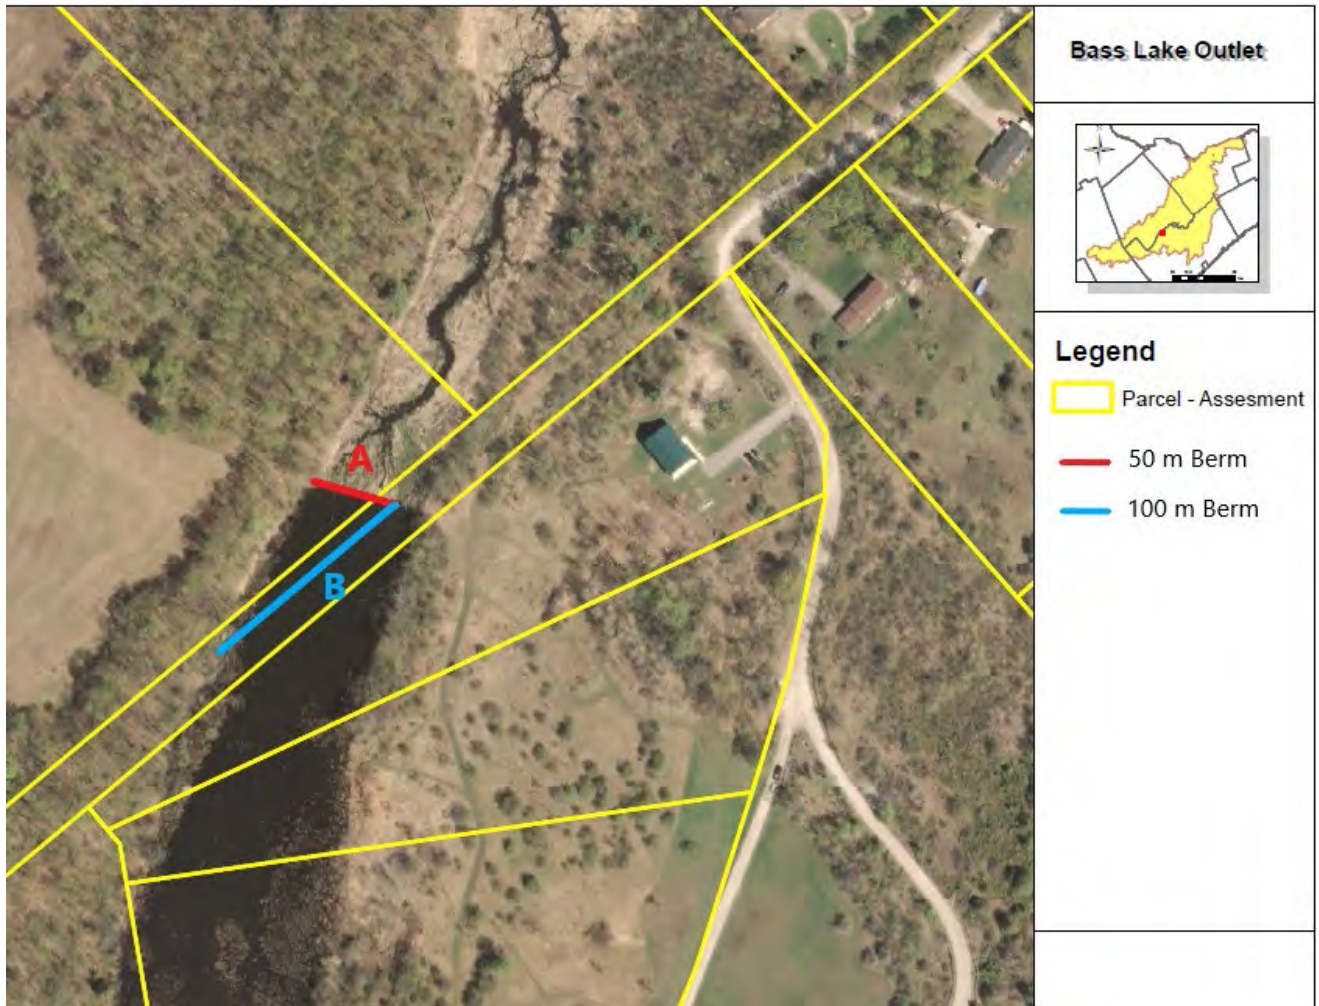
associated with property and ownership negotiations; however, it would have a significantly increased environmental impact and construction costs and may not receive approval from regulatory authorities unless it can be proven to be necessary for emergency or safety reasons. This option is shown as the blue line 'B' on **Figure 4-2**.

Figure 4-2. Property lines are shown in vicinity of the Bass Lake outlet. The red A line denotes existing berm, while the blue B line indicates a possible orientation to avoid construction on private property.

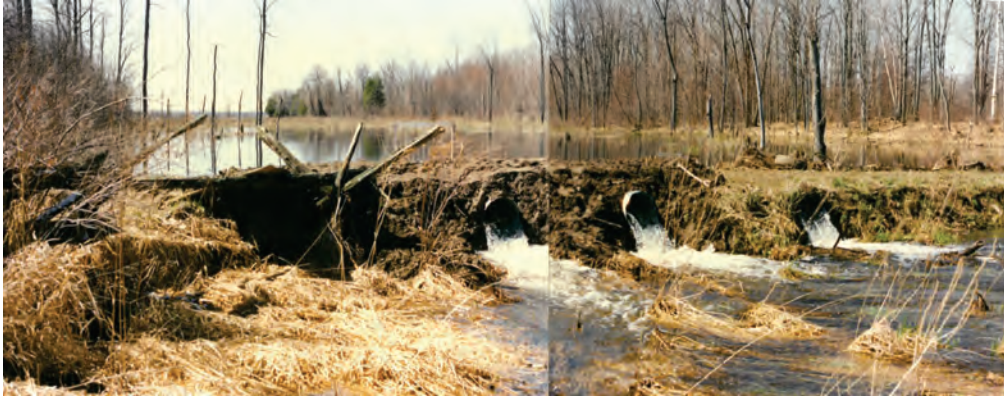
2. Rehabilitate Existing Berm

The existing berm could be rehabilitated to maintain the water surface elevations experienced by residents and lake users over the past quarter century. It is possible that this would be considered the new normal in terms of wetland functionality, ecosystem health, and riparian rights and therefore confer the least liability onto the Township; however, it is recommended to consult an experienced legal opinion before proceeding under this assumption. The rehabilitation of the berm could be completed using typical construction materials and methods and would require minimal alterations to the existing structure's footprint. This would facilitate the approval process and reduce environmental impacts from construction activity. However, due to the inherently unstable nature of the existing structure, ongoing monitoring and maintenance would likely be required to ensure the desired water levels are maintained.

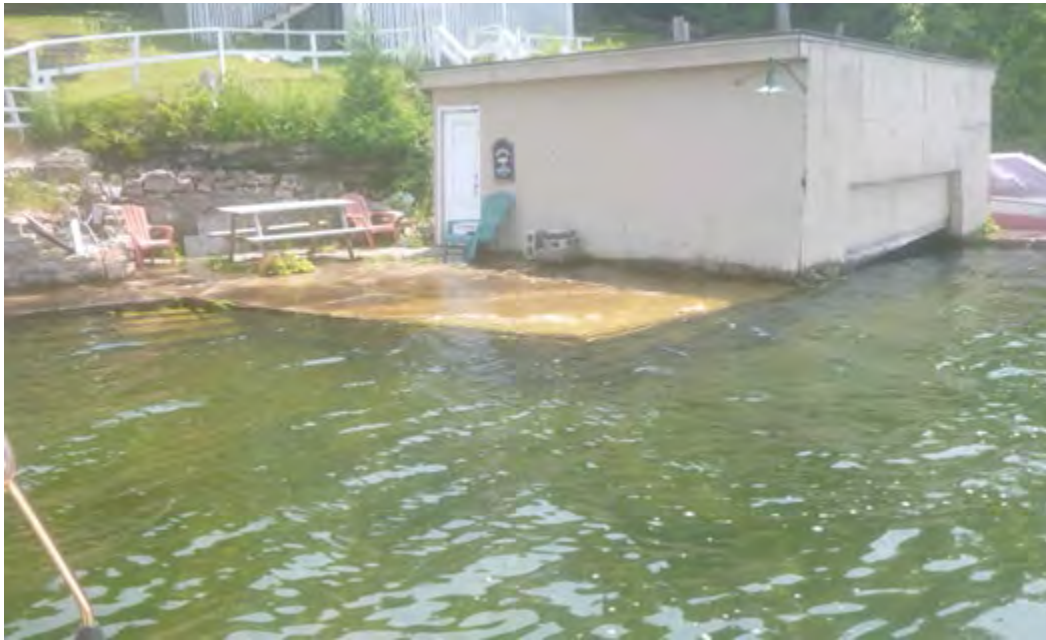
A resident of Bass Lake in attendance at the public information session on June 22, 2019 noted that their family had owned property on Bass Lake for over 50 years and had developed their property according to the water levels experienced prior to 1995. Since the illegal construction of the earthen berm, they have documented flooding of private property, as shown below.

Resident-submitted photo showing private property flooding. Circa July, 2015
